BAY STREET CONDOMINIUMS

Bay Street Condominiums, Watch Hill RI

DESCRIPTION:

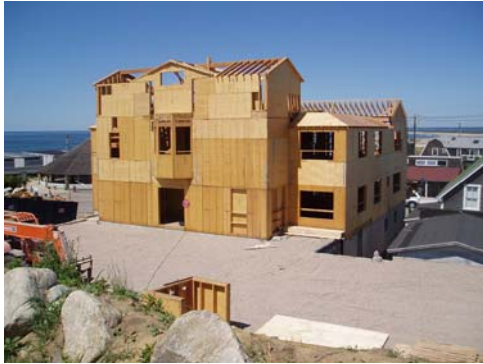
Wood framing in progress

- The main framing consists of steel moment frames, engineered lumber, and plywood shear walls.
- Steel moment frames, plywood shearwalls, and metal connectors and holdowns are also used to protect the building from high winds that may occur during a hurricane. Impact resistant windows are installed to protect from wind-borne debris.

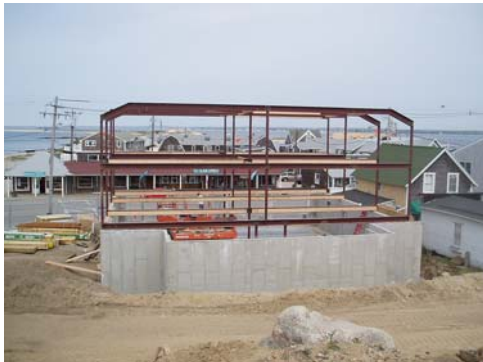
Concrete walls and steel moment frames

- Piles, concrete grade beams, and a pile supported structural slab are used to provide a stable foundation for the structure.
- The first floor is several feet below the FEMA flood elevation. Dry flood proofing methods are used to protect the building and its contents in the event of a flood. The first floor perimeter walls are constructed of reinforced concrete with waterproof joints. The concrete slab is designed to resist hydrostatic forces. In the event of a storm, metal flood gates are used to stop water and floating objects from damaging and entering the first floor doors and windows.

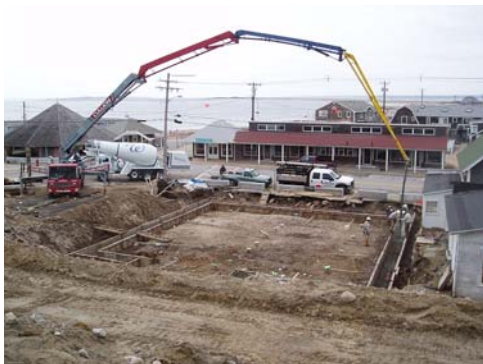
Installation of perimeter grade beams on piles
